**NATA TEST REPORT NO.: 8554**

**Report Date:** 17<sup>th</sup> July 2024  
**Client:** SAI Sandstone  
**Address:** 5 Hamilton Street  
Oakleigh VIC, 3166  
**Attention:** Bob Lu & Jessie Weng  
**By Email:** [bob@saistone.com.au](mailto:bob@saistone.com.au)  
[jessie@saistone.com.au](mailto:jessie@saistone.com.au)  
**Sample(s):** 1 x Limestone Pavers (5 units)  
**Sampled By:** Client  
**Lab Number(s):** 24/N/2085  
**Client Reference:** Moon Light Grey  
**BMRL NATA No.:** 658  
**Date Received:** 4<sup>th</sup> June 2024  
**Project:** Testing of Stone

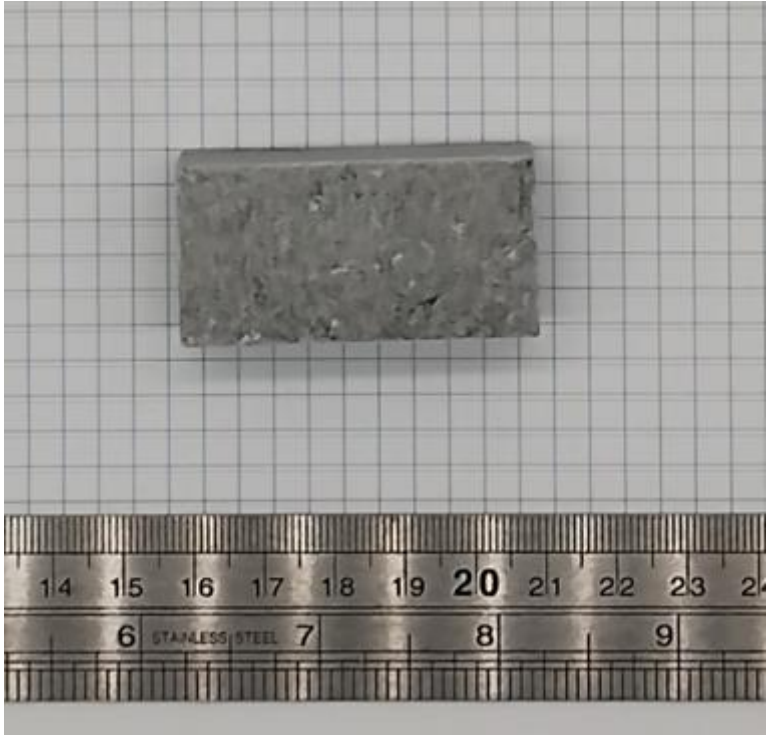
| <b>Photo:</b> | |

| <b>Sample Markings:</b> | Moon Light Grey |
| <b>Type of Unit:</b> | Limestone |
| <b>Test Sizes, mm:</b> | 50 ± 2 mm x 25 ± 2 mm x 16 ± 5 mm |
